IN-LINE INSPECTION OF CO₂ PIPELINES – OPPORTUNITIES AND CHALLENGES

Jochen Spalink, Dr. Hubert Lindner, Thomas Beuker of the ROSEN Group

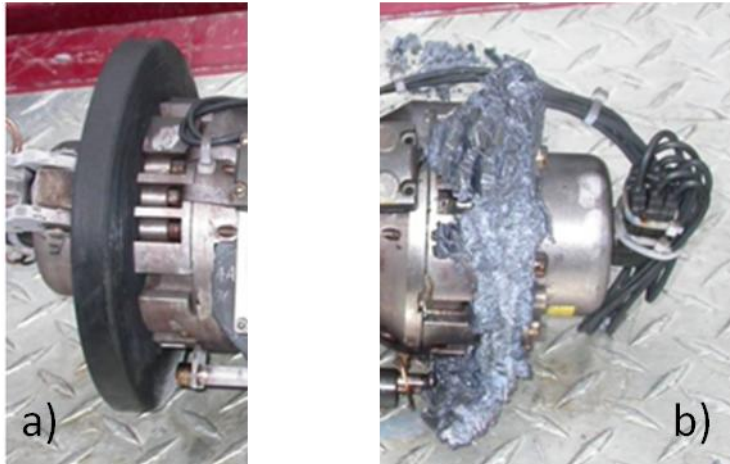
An extreme example for the potential of an adapted polyurethane (PUR) composition is shown in figure 1. It shows a test sample including a standard PUR disc after 48 hours of exposition to high pressure ammonia. The remaining PUR is only a mass of steaming material. After the ammonia has been diffused, the material falls into a heap of ashes clearly showing that standard PUR is absolutely not usable in ammonia. ROSEN has therefore developed an ammonia resistant PUR which is shown in figure 2. The shown 6" pull unit is fully equipped with ammonia resistant PUR and two ring brushes for support, and is able to pull a 6" MFL tool through an 82 km long pipeline, in total an exposition time of 60 hours.

Figure 1: Polyurethane cup samples exposed to Ammonia over a period of 24h.
a) Optimized composition b) Standard polyurethane

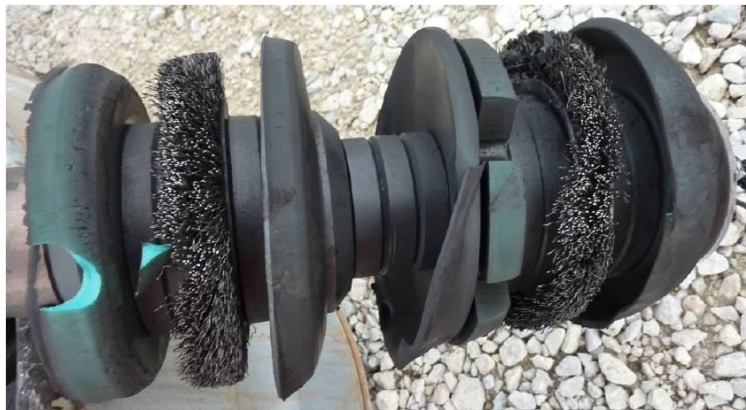
Figure 2: Ammonia PUR on a 6" pull unit after 82 km and 60 hours exposition time.

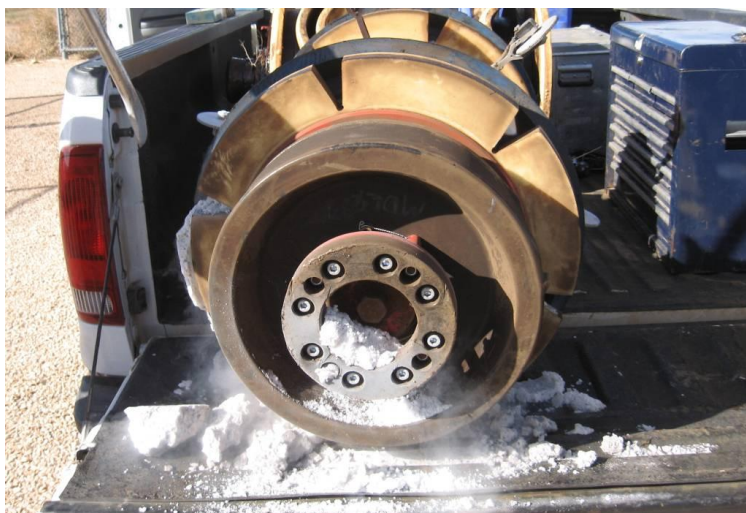
The pipeline transported CO₂ at a high pressure of 131 bar and a launching temperature of about 16 °C for 116 km. Because of a very low flow rate, the inspection duration was about 180 hours. The line was inspected with two separate tools and technologies: an electronic geometry tool (RoGeo) and a MFL tool. Figure 3 shows a rear view of the RoGeo tool after the run. The run was successful and no damage was reported. This is confirmed by the picture, where there is no visible effect or extreme wear after a long run and a long exposition time. The snow like substance visible on the tool is carbon dioxide snow which forms directly as the CO₂ steams out into the air. This occurs due to decompression. Several hours later in the workshop, the plastic and rubber parts of the tool begin to show signs of bubbling (figure 4).

Clearly, the cups and discs are not remarkably affected. The cups do not show deformation compared with the buffer, and do not even have bubbles. This is a first indication of the performance of the different materials. The cups and discs of RoGeo are produced with a hardness of 85 Shore whilst the buffer is manufactured with a different and softer material (65 Shore) and the RoGeo sensor is casted with a similar composition to that of PUR.

Figure 3: Geometry tool after 116 km in high pressure CO₂.

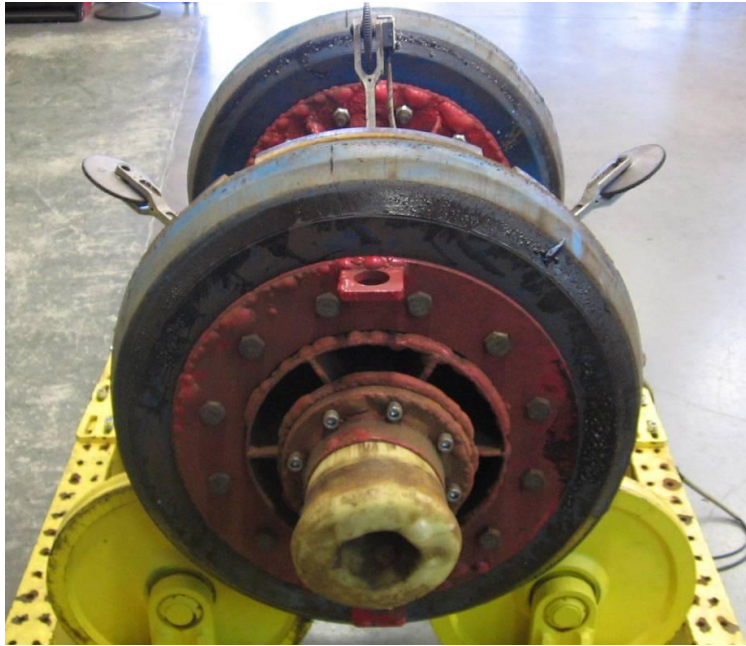
Figure 4: Front view on ROSEN's Electronic Geometry tool, hours after the run with swollen buffer and bubbling painting.

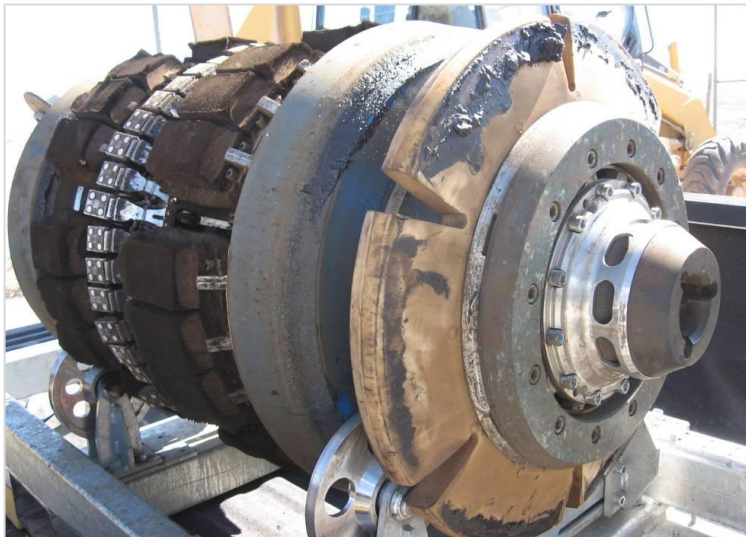
The inspection with the MFL tool was successful and the tool showed no extreme wear on the cups and the disc (see figure 5) such as those on RoGeo. A difference is appearance of the high number of cables a short time after receiving. As shown in figure 6 the cable loop is completely swollen already shortly after the run. One day later, the cables are visibly back to their original condition. On this tool a little effect on the guiding disc could be observed (figure 7). Back in the workshop after the run, some bubbles and deformations are visible, but not to a disconcerting extent.

Figure 5: MFL tool after the run in 116 km high pressure CO₂.

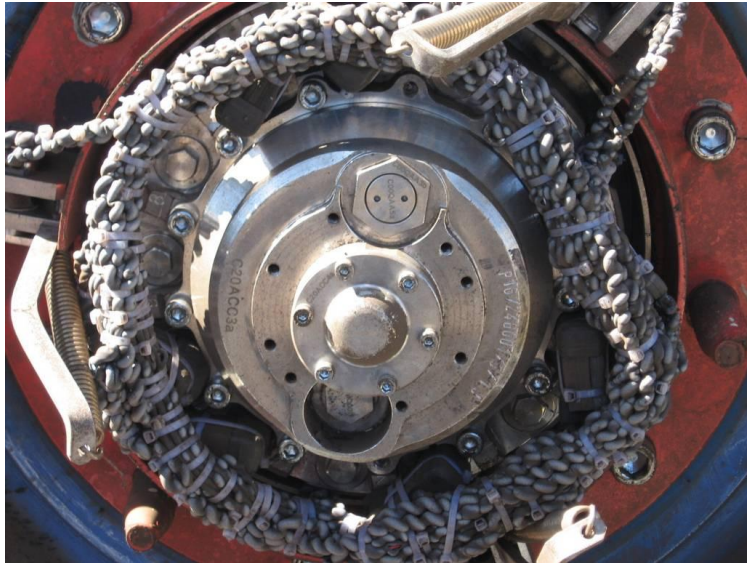
The result for the MFL run was similar: the guiding discs and cups were in good condition, however the cables, sensors and connections were affected (same result as displayed in figure 6).

Figure 6: Rear view of 24" MFL tool after the run with extremely swollen cables.

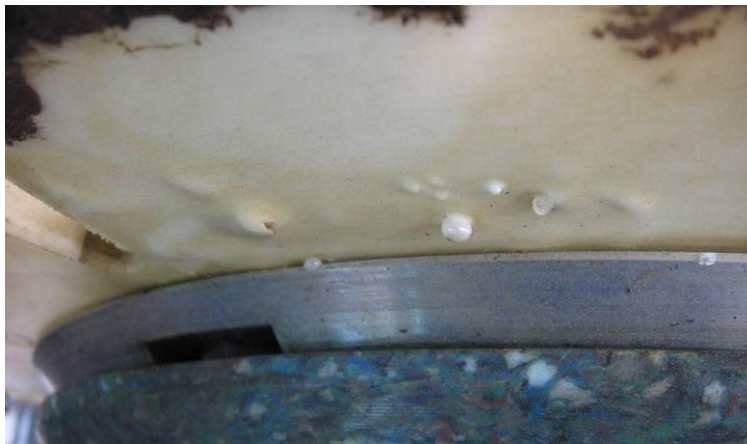
Figure 7: Guiding disc of 24" MFL in the workshop with visible bubbles.

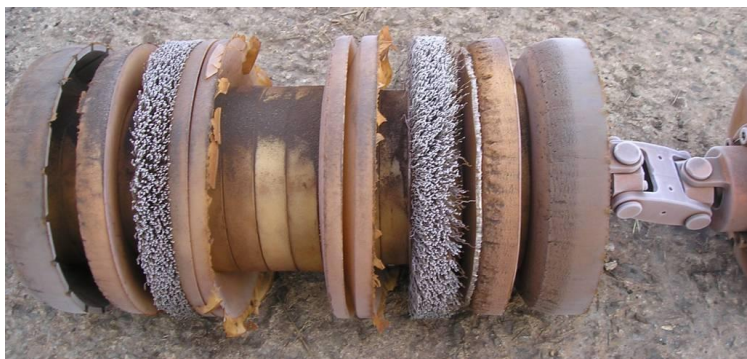
This example was chosen because of its extreme conditions and small size. The line is known to be critical. The client could not get a cleaning tool into the receiver because of the medium (very dry), the amount of debris in the pipeline (typical for ethylene), and the pipeline length in relation to the small size. Therefore, an adapted cleaning tool was designed to cater for these criteria. After successful performance of the cleaning tool, it was used also as a pull unit (figure 8) for the MFL inspection tool. Because of the expected very heavy abrasion, further modifications were made to prevent excessive wear of the cups of the electronic units. These were reinforced with sliding bolts inside the cups' surfaces to reduce the wear on the lips of the cups. Although heavy abrasion is clearly visible, the modification provided enough resistance to allow a successful line inspection.

Figure 8: Pull unit for 8" line after 102 km in 60 bar ethylene.

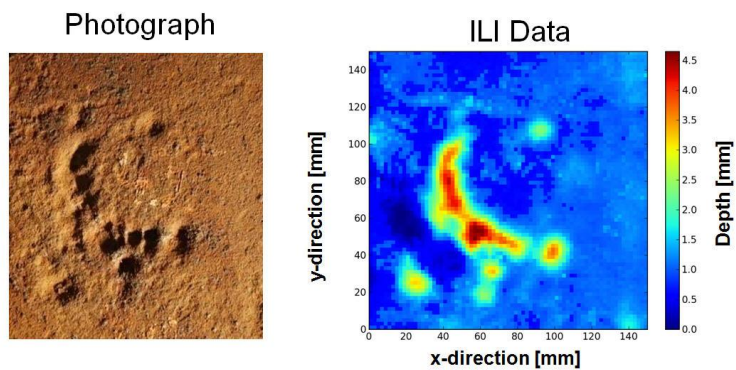
Figure 11: Comparison of the high-resolution mapping data for shallow internal corrosion, and the corresponding photograph.

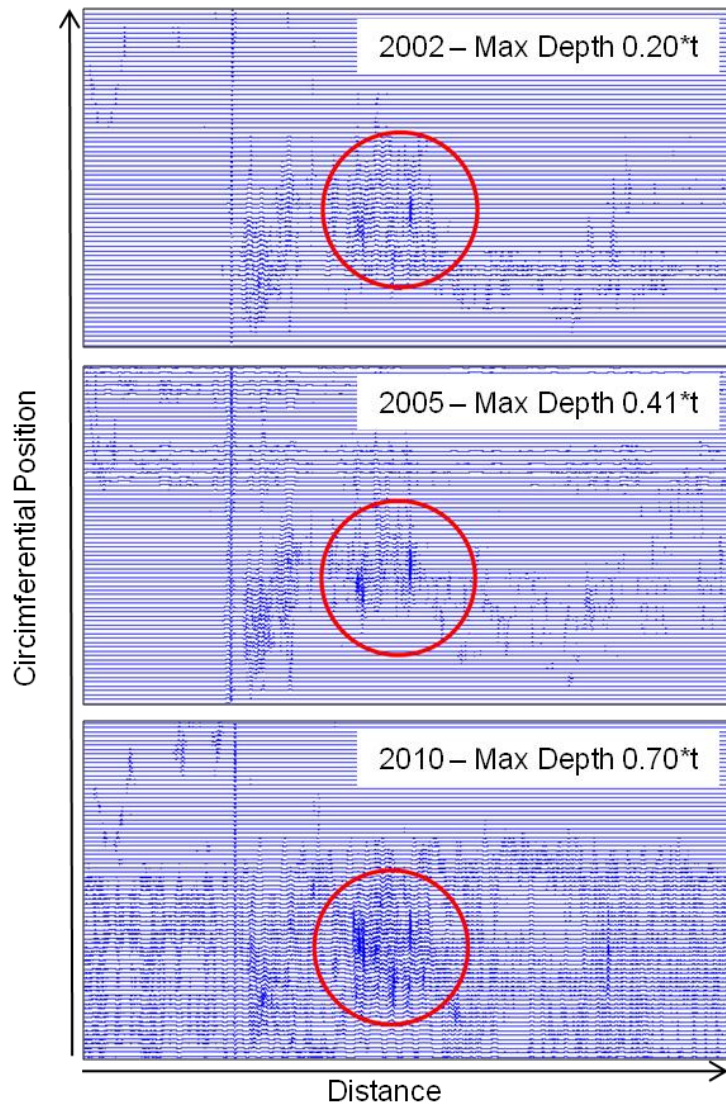
To derive reliable corrosion growth rates, a two tear process is suggested. At first, the reported anomalies from subsequent inspections are mapped against each other. Secondly, the normalized inspection signals are compared to compensate the systematic and random error from both runs. An example of such a comparison is given in figure 12. Data from three subsequent inspection surveys are shown. The signal pattern of a girth-weld can clearly be identified and is used for reference. The individual inspection report only gives the maximum depth of the corrosion area in question. However, comparing the raw ILI data clearly shows, that light corrosion is already present. This corrosion has not been reported, since it was below the contractually agreed reporting threshold. Nevertheless, for the calculation of a corrosion growth rate and to better understand the mechanism of deterioration, the additional information drawn from the raw data is crucial.

Figure 12: Example of corrosion growth monitoring based on an MFL signal data. The individual inspection report depicts the maximum depth for general corrosion only. However a comparison of the normalized raw data indicates sub-threshold corrosion growth in the surrounding area of the reported anomaly.
