IPC2006-10157

IN-LINE INSPECTION OF DENTS AND CORROSION USING "HIGH QUALITY" MULTI-PURPOSE SMART-PIG INSPECTION DATA

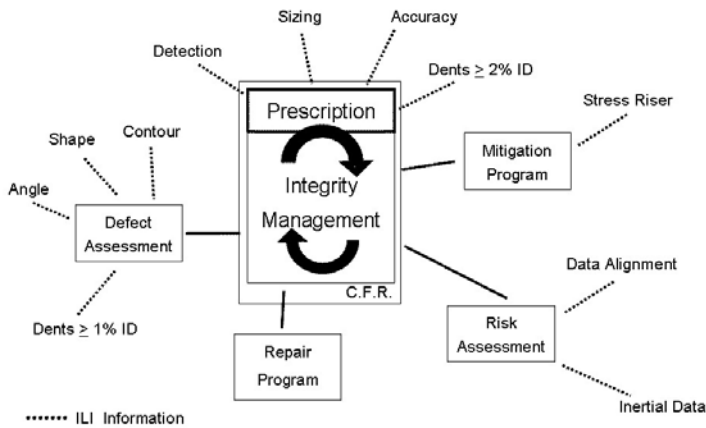
Figure 1: The Integrity Management process typically goes beyond the evaluation of the purely prescriptive information

A “high-quality” ILI process for dents and mechanical damage can provide required information such as the geometry of dents and data on stress risers to start a managed integrity process for the inspected line (refer to Figure 1). The more high-resolution and “high-quality” information that is available about an anomaly found, the better the subsequent failure analysis can be.

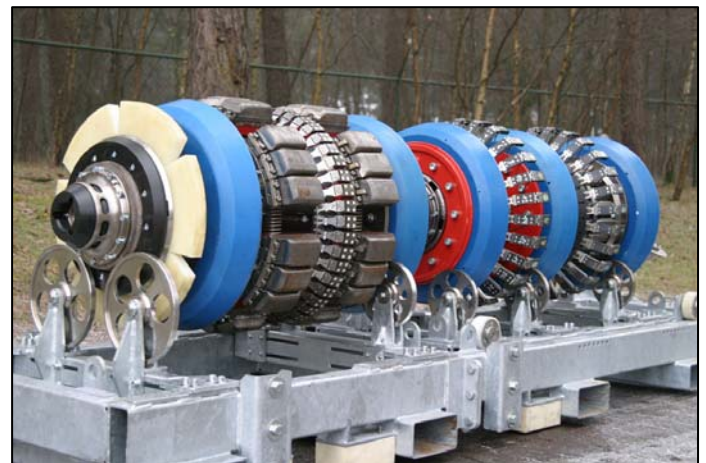
Figure 2: ILI multipurpose 24” tool. Combining MFL technology with high quality geometry inspection. Two measurement planes for the geometry sensor are required to provide full coverage under all operational conditions.

of the stress riser are high-resolution ILI tools based for example on the magnetic flux leakage principle. In combination with one of these tools, a “high-quality” geometry tool and a navigation unit can be combined on a multipurpose tool (Figure 2), so that the required data can be obtained during a single inspection run.

Therefore, an accurate sizing of dents or other geometric anomalies in a pipeline requires 100% coverage over the circumference by the geometry sensors. To achieve this, the inspection solution must consist of two inspection planes, where the trailing sensor unit is covering the gap of the preceding unit. The tool design for the ROSEN high-resolution geometry inspection system (XGP) consists of two sensor units circumferentially offset to each other and hence guarantee 100% physical coverage of the internal surface (refer to Figures 2).

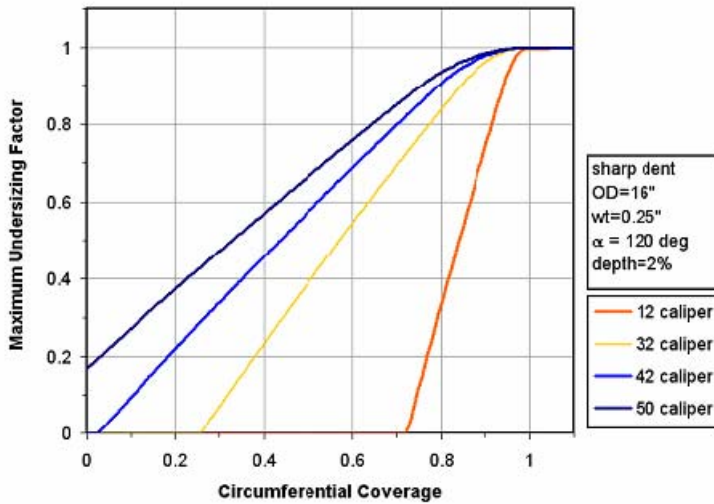
Figure 3: Undersizing of dents as a function of coverage and number of caliper arms for a sharp dent with a tip angle $\alpha=120^\circ$. The maximum undersizing factor is a worst case scenario.

Due to the linear equation connecting the pipeline diameter with its circumferential perimeter, the coverage of a single unit tool is linked to the ID-passage of the unit. A fully assembled single inspection plane would also complicate the negotiation of 1.5D bends. As a rule of thumb, the coverage for a single plane geometry tool equals the specified passage minus 15%. Thus, a typical caliper tool with a passage of 75% would cover only 60% of the physical internal pipe surface. This can lead to a significantly reduced POD and to an undersizing of the dent depth as the internal contour is not been sampled completely. (refer to Figure 3).

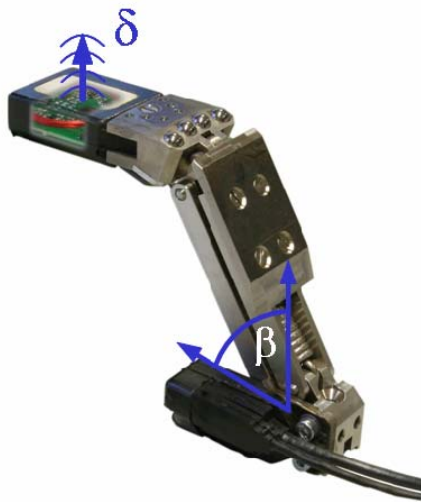
Figure 4: Combination of conventional mechanical caliper concept(B) with a touchless operating proximity sensor (d).

Figure 4 shows the touchless electronic sensor integrated inside the sensor head and a position sensor attached at the base of the sensor arm monitoring the mechanical position. The touchless electronic sensor is used to compensate data obtained from the dynamic behavior of the caliper arm. The unwanted effects of the caliper's inertia is fully assimilated by the touchless measurement. Sharp transitions at the internal surface, such as a pipe misalignment at a girth weld, are monitored very well. Another example explains how the contour of a dent is monitored by the compensation method. Figure 5 shows the result simulated at 6.72mph (3 m/s).

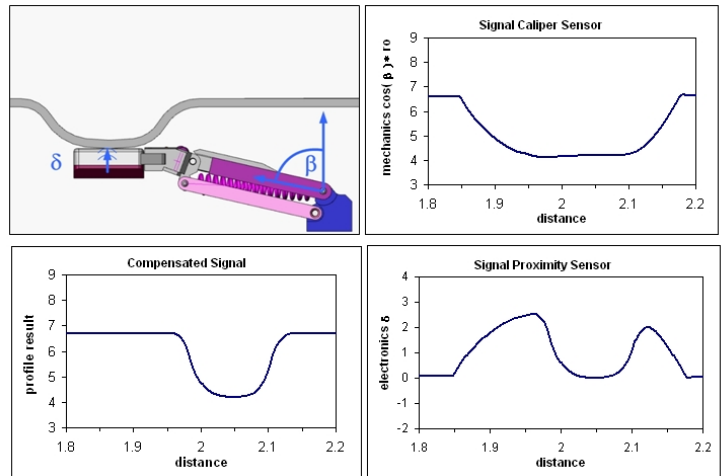
Figure 5: Compensated signal from a dent obtained with the by summation of the mechanical movement measurement and the touchless proximity signal.

This example also emphasizes the tendency of oversizing the dent length by a pure mechanical caliper arm.

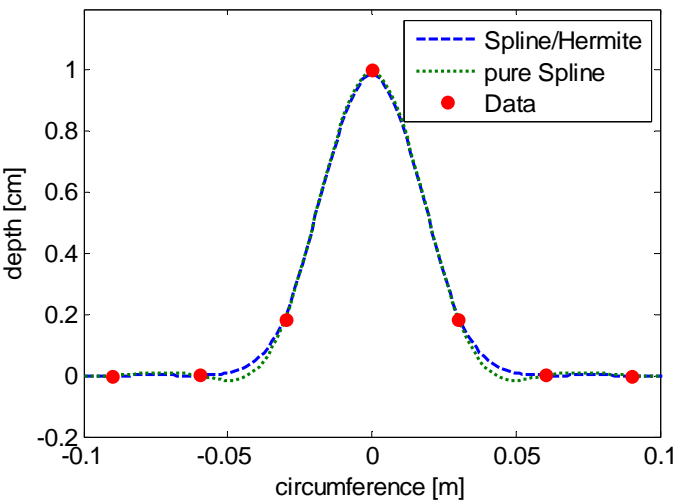
Figure 6: Dent Depth over circumference for a small gaussian defect shape. The spline solution tends to overshoot.

For this reason, a combination of spline and Hermite interpolation is used to achieve optimum results for static strain analyses around dents. Moreover, depending on the dent geometry the weighting of the two basic principles has to be designed properly to achieve the right approximation, respectively. The improvement in the resulting curvature can be seen in figure 6. The pure spline interpolation generates artificial curvatures at the border ($\pm 0.06\text{m}$) of a small Gaussian shaped dent.

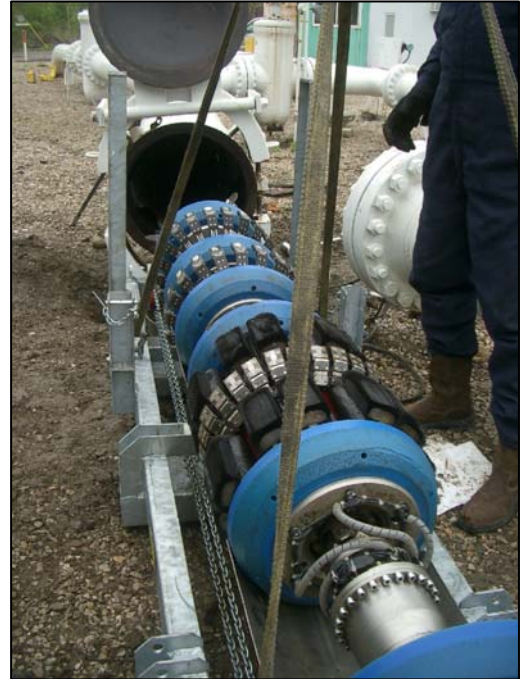
Figure 7: Multipurpose toolMFL, HighRes Geometry and IMU, at the receiver site.

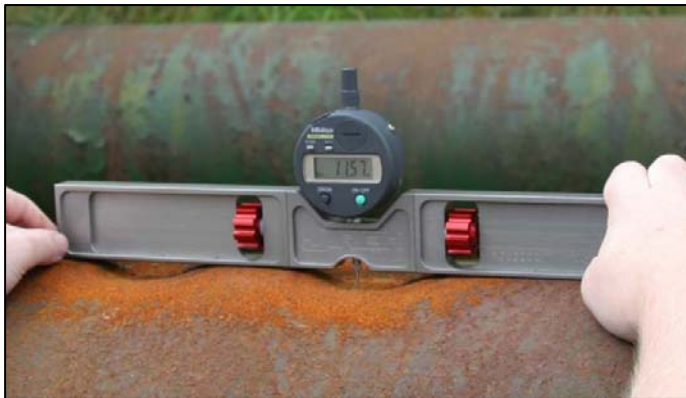
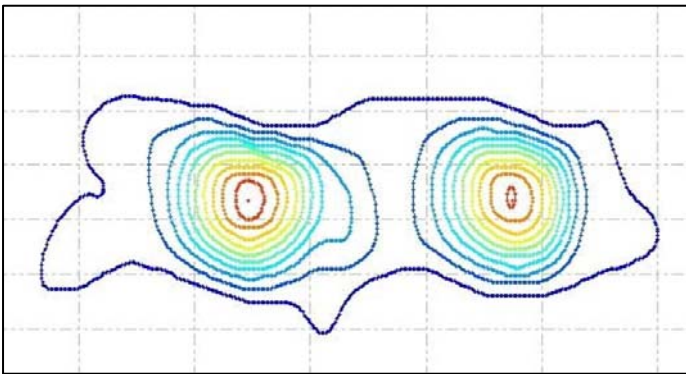
Figure 8: Series of two dents adjacent to each other. Inspection data obtained with the 16" ILI system (below). The maximum depth of the dent was found to be 2.9% OD.

Two short dents for example, adjacent to each other in the axial direction are correctly recorded (to figure 8). An artificial dent, with an almost rectangular shape is captured in the data accordingly (figure 9). Wrinkles in the pipeline are accurately mapped by the system. The touchless sensors provide accurate depth information without the requirement of following the contour mechanically (figure 10).

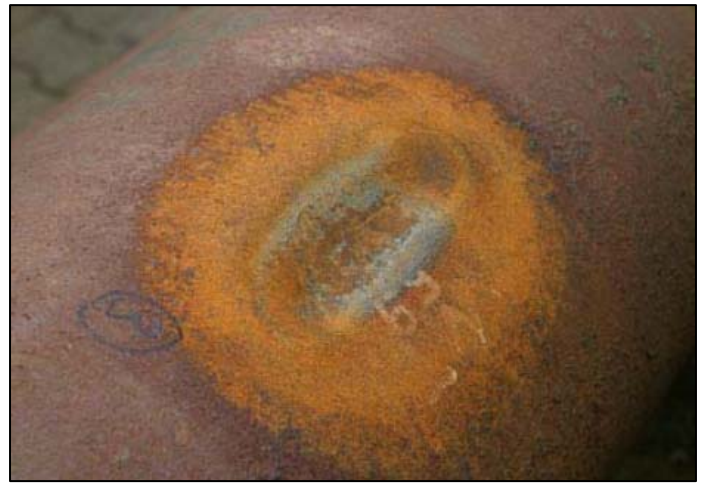
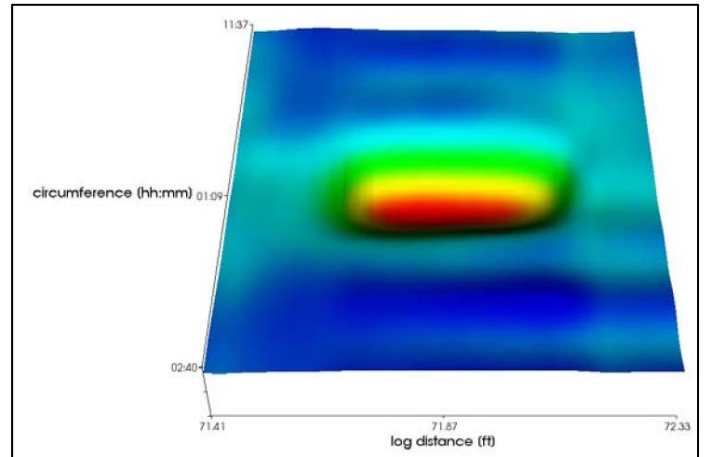
Figure 9: Artificial dent with almost rectangular contour. Inspection data obtained with the 16" ILI system (below). The characteristic shape is well reflected within the data.

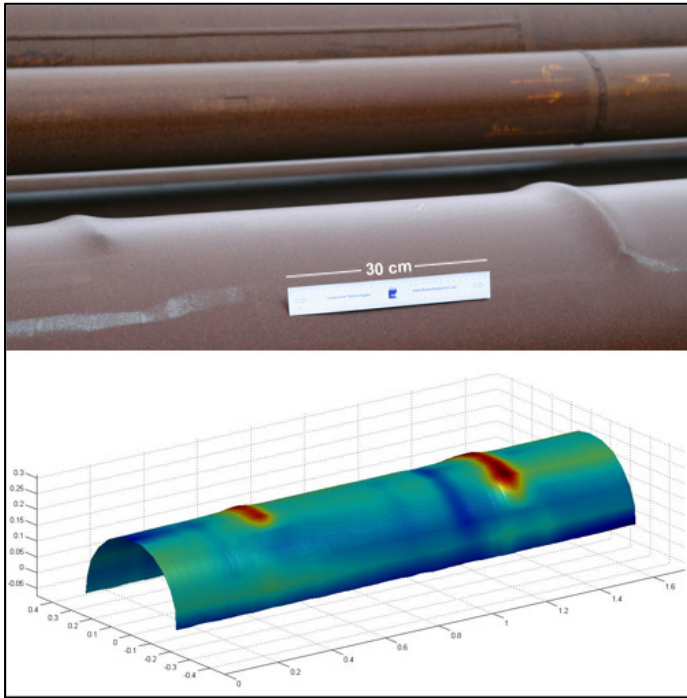
Figure 10: Mapping of wrinkles. Inspection data obtained with the 16" ILI system (below). The touchless sensor provide accurate depth information without the requirement of following the contour mechanically .
